1938 INTERNATIONAL D15R

It may have taken 23-years to complete the restoration of my D15R International, but the end result is more than impressive having taken it from the paddock to the showroom.

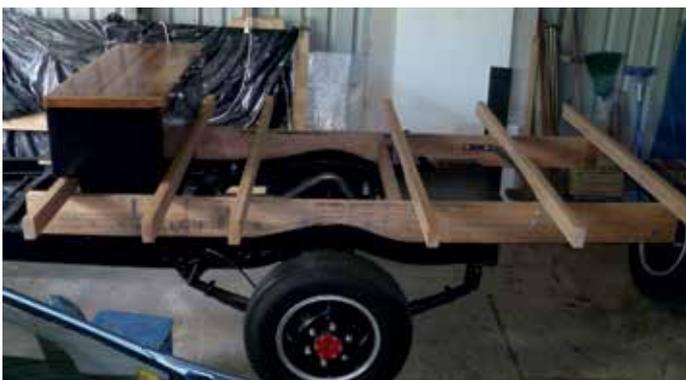
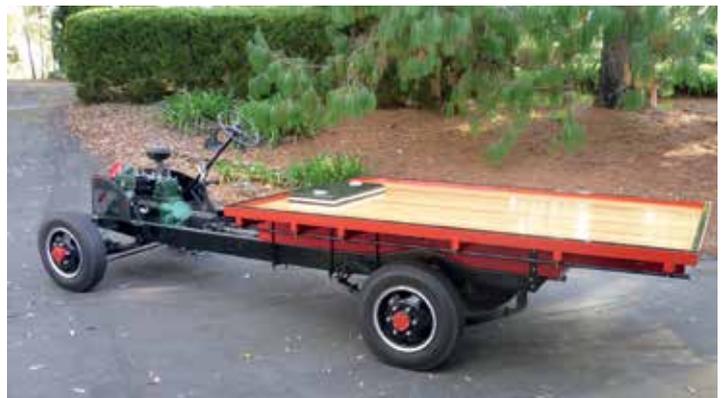
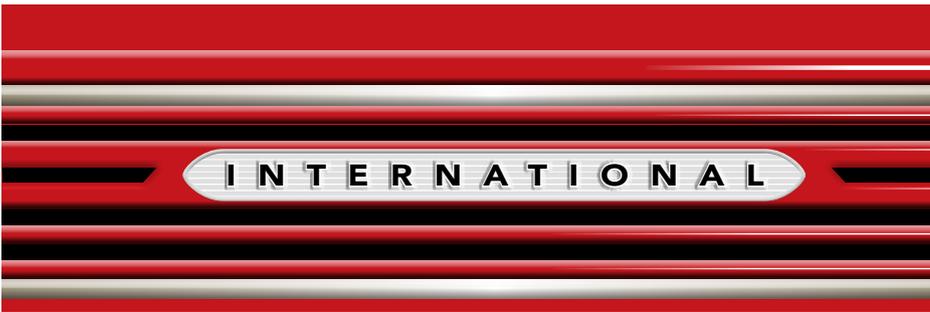
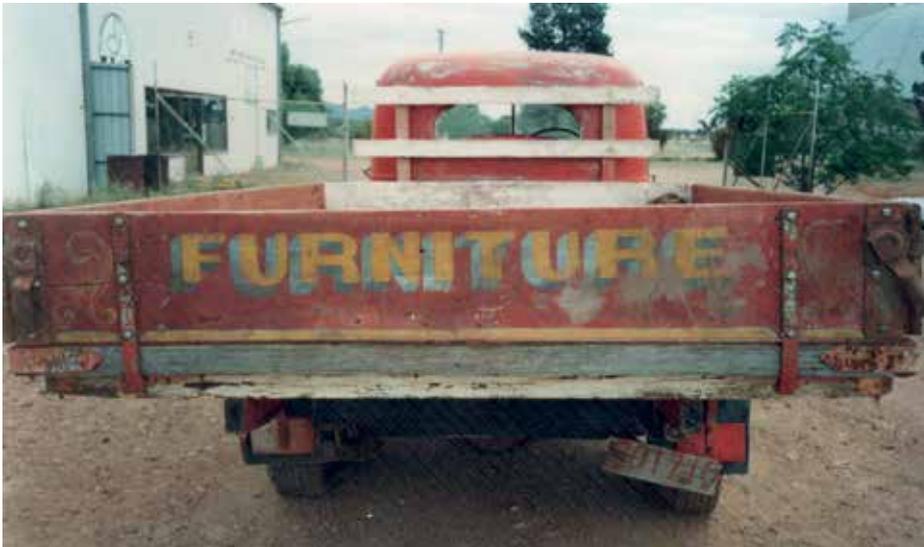
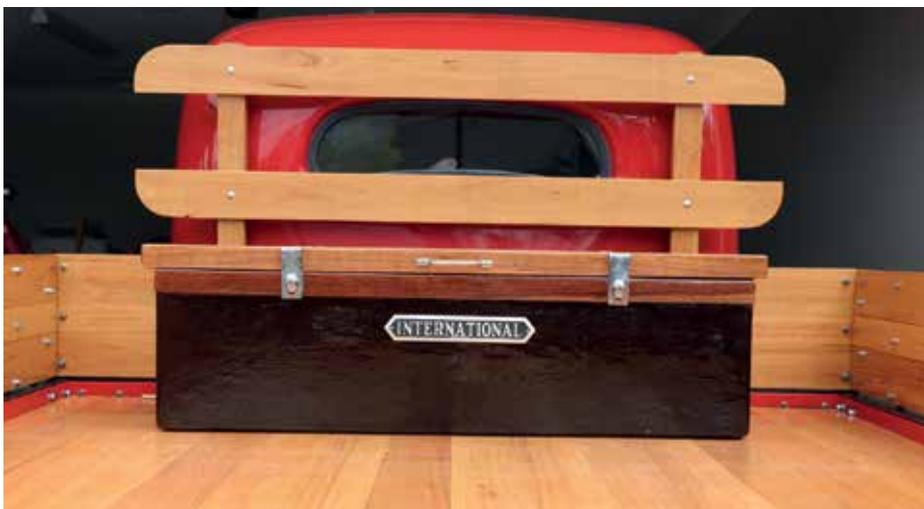
The old chassis beams were made up of two separate size timbers one on top of the other, being 4 x 2 inches and 3 x 2 inches. The later was shaped to accommodate the hump in the chassis over the rear axle. I made the executive decision to use a one-piece member 200mm x 50mm, and cut out the hump where required. This provided better stability and support for the cross members. Each of the chassis beams was 10ft long, just over 3 metres, and damn heavy for me to handle. Setting each beam alongside the chassis rail I scribed the shape of the rail on the side of the beam, then using a jigsaw with a suitably long enough blade I

set about cutting out the required shapes. It was hard going and tiring work. It took about 5 hours over two days to cut the first piece, then taking several hours longer to cut the second piece, as the blade was blunt and kept ripping out of the machine. I also cut out a curved piece where the fuel tank filler pipe passed through.

The next task was to cut the shape in the beam where it cantilevered over the rear of the chassis. It didn't seem to take as long but it was still hard going even though I had mastered the knack, speeding up the process. All up it took about four weekends to complete all the curved work. My arms, shoulders and back needed a break after this

With all the curves cut out, I moved onto making all the square cuts. The cantilevered ends of the main beams and each end of the cross members had to have a 200 x 20 triangular wedge piece cut off the underside. Once marked up, the circular saw made reasonably short work of this step.
